Relating Stage to Discharge in Red Butte Creek

Jem Locquiao, University of Utah
Christine Pomeroy, University of Utah

Department of Civil and Environmental Engineering

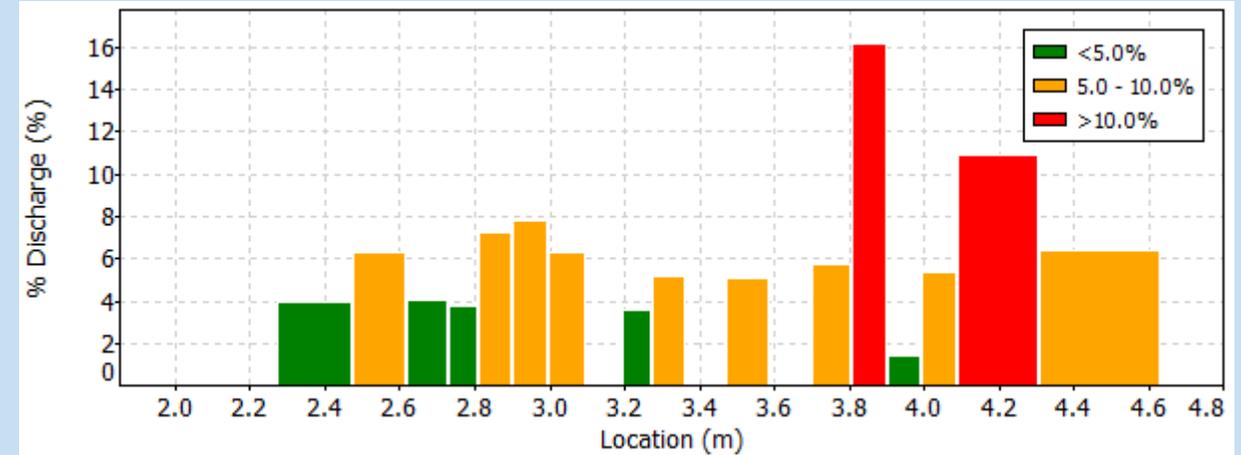
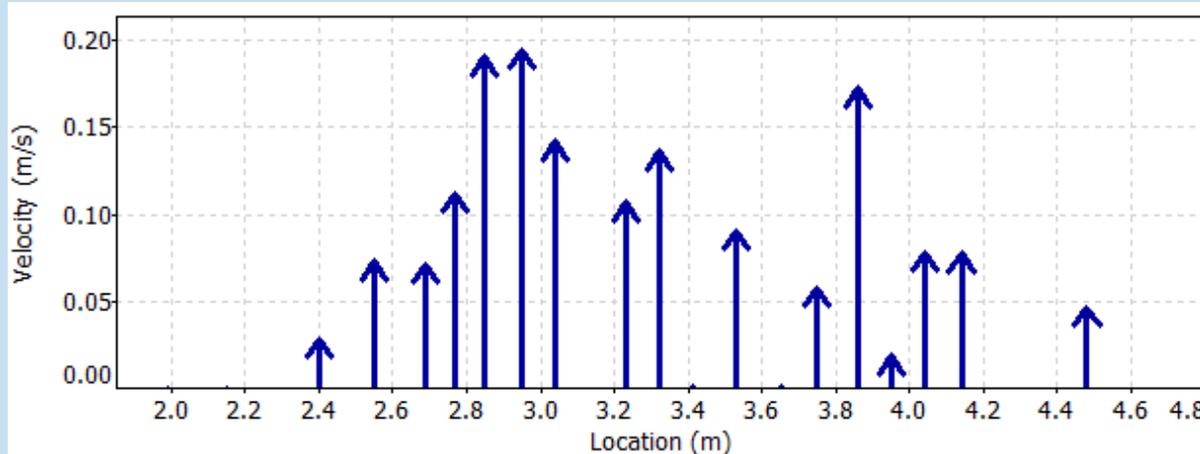
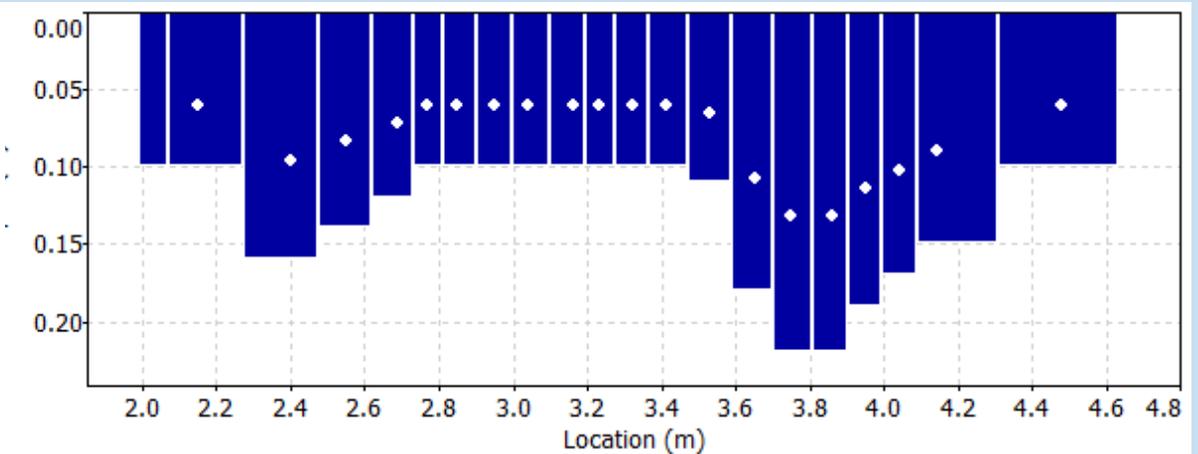
Quality Control			
St	Loc	%Dep	Message
2	2.40	0.6	Boundary QC is Good; possible boundary interference
9	3.16	0.6	High differences in beam SNR: 45.5,63.2
		0.6	SNR (54.4) is different from typical SNR (32.5)
10	3.23	0.6	Boundary QC is Fair; possible boundary interference
12	3.41	0.6	Boundary QC is Poor; possible boundary interference
14	3.65	0.6	SNR (15.7) is different from typical SNR (32.5)
		0.6	Boundary QC is Fair; possible boundary interference
15	3.75	0.6	Boundary QC is Fair; possible boundary interference
16	3.86	0.6	High number of spikes: 7
		0.6	High differences in beam SNR: 6.4,19.7
		0.6	SNR (13.1) is different from typical SNR (32.5)
		0.6	High standard error: 0.093
19	4.14	0.6	High angle: 28
21	4.78	0.6	Low SNR: 0.0,0.0
		0.6	SNR (0.0) is different from typical SNR (32.5)
		0.6	High standard error: 0.256

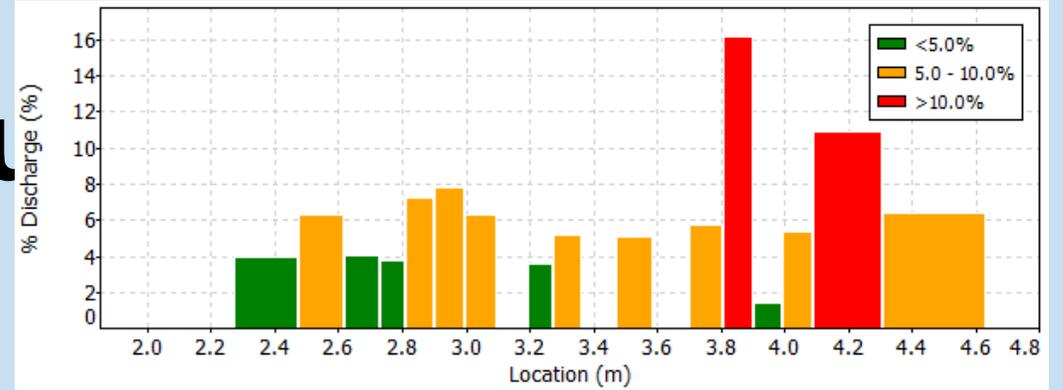
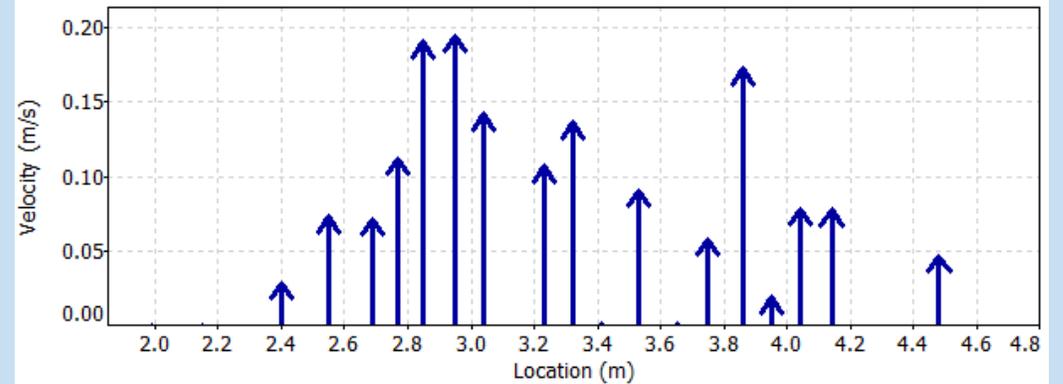
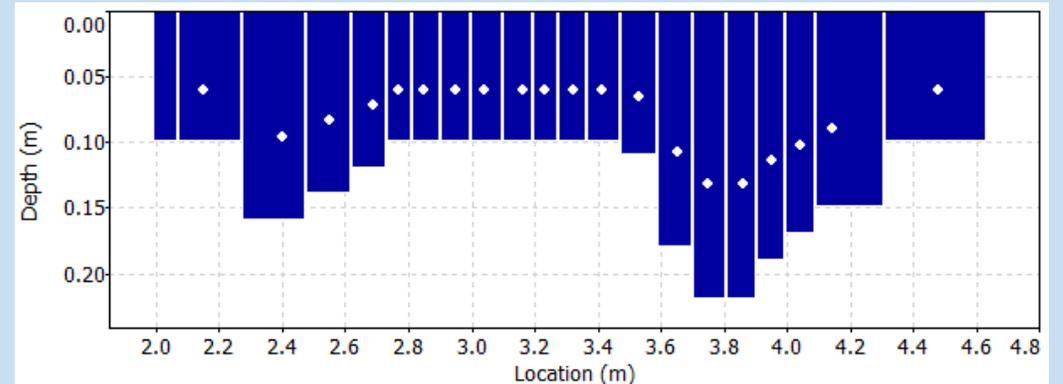
Measurement Results												
St	Clock	Loc	Method	Depth	%Dep	MeasD	Vel	CorrFact	MeanV	Area	Flow	%Q
0	13:24	1.99	None	0.100	0.0	0.0	0.0000	1.00	0.0007	0.008	0.0000	0.0
1	13:24	2.15	0.6	0.100	0.6	0.040	0.0007	1.00	0.0007	0.021	0.0000	0.1
2	13:33	2.40	0.6	0.160	0.6	0.064	0.0293	1.00	0.0293	0.032	0.0009	4.0
3	13:34	2.55	0.6	0.140	0.6	0.056	0.0734	1.00	0.0734	0.020	0.0015	6.3
4	13:36	2.69	0.6	0.120	0.6	0.048	0.0719	1.00	0.0719	0.013	0.0009	4.0
5	13:37	2.77	0.6	0.100	0.6	0.040	0.1126	1.00	0.1126	0.008	0.0009	3.8
6	13:38	2.85	0.6	0.100	0.6	0.040	0.1908	1.00	0.1908	0.009	0.0017	7.3
7	13:40	2.95	0.6	0.100	0.6	0.040	0.1947	1.00	0.1947	0.010	0.0018	7.9
8	13:41	3.04	0.6	0.100	0.6	0.040	0.1424	1.00	0.1424	0.011	0.0015	6.4
9	13:43	3.16	0.6	0.100	0.6	0.040	0.0000	1.00	0.0000	0.010	0.0000	0.0
10	13:44	3.23	0.6	0.100	0.6	0.040	0.1073	1.00	0.1073	0.008	0.0009	3.6
11	13:47	3.32	0.6	0.100	0.6	0.040	0.1365	1.00	0.1365	0.009	0.0012	5.2

12	13:50	3.41	0.6	0.100	0.6	0.040	0.0014	1.00	0.0014	0.011	0.0000	0.1
13	13:51	3.53	0.6	0.110	0.6	0.044	0.0908	1.00	0.0908	0.013	0.0012	5.1
14	13:56	3.65	0.6	0.180	0.6	0.072	0.0019	1.00	0.0019	0.020	0.0000	0.2
15	14:00	3.75	0.6	0.220	0.6	0.088	0.0582	1.00	0.0582	0.023	0.0013	5.7
16	14:02	3.86	0.6	0.220	0.6	0.088	0.1729	1.00	0.1729	0.022	0.0038	16.2
17	14:03	3.95	0.6	0.190	0.6	0.076	0.0197	1.00	0.0197	0.017	0.0003	1.4
18	14:05	4.04	0.6	0.170	0.6	0.068	0.0787	1.00	0.0787	0.016	0.0013	5.4
19	14:08	4.14	0.6	0.150	0.6	0.060	0.0778	1.00	0.0778	0.033	0.0026	10.9
20	14:11	4.48	0.6	0.100	0.6	0.040	0.0470	1.00	0.0470	0.032	0.0015	6.4
21	14:13	4.78	0.6	0.000	0.6	0.000	0.3665	1.00	0.0000	0.000	0.0000	0.0
22	14:13	4.80	None	0.000	0.0	0.0	0.0000	1.00	0.0000	0.000	0.0000	0.0

Rows in italics indicate a QC warning. See the Quality Control page of this report for more information.

Quality Control			
St	Loc	%Dep	Message
2	2.40	0.6	Boundary QC is Good; possible boundary interference
9	3.16	0.6	High differences in beam SNR: 45.5,63.2
10	3.23	0.6	SNR (54.4) is different from typical SNR (32.5)
10	3.23	0.6	Boundary QC is Fair; possible boundary interference
12	3.41	0.6	Boundary QC is Poor; possible boundary interference
14	3.65	0.6	SNR (15.7) is different from typical SNR (32.5)
14	3.65	0.6	Boundary QC is Fair; possible boundary interference
15	3.75	0.6	Boundary QC is Fair; possible boundary interference
16	3.86	0.6	High number of spikes: 7
16	3.86	0.6	High differences in beam SNR: 6.4,19.7
16	3.86	0.6	SNR (13.1) is different from typical SNR (32.5)
16	3.86	0.6	High standard error: 0.093
19	4.14	0.6	High angle: 28
21	4.78	0.6	Low SNR: 0.0,0.0
21	4.78	0.6	SNR (0.0) is different from typical SNR (32.5)
21	4.78	0.6	High standard error: 0.256

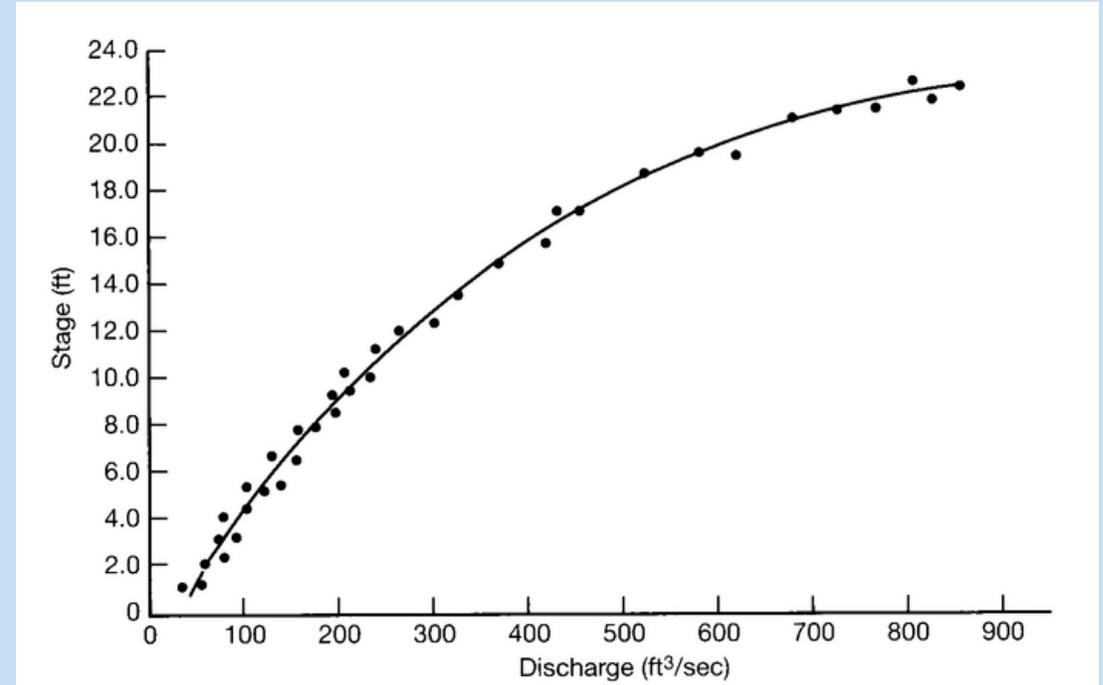
Characterize streamflow and cross-section characteristics

Develop rating curve
